Manhole Inspection Summary

Manhole # S47G__038MH

Insp Date: **5/1/08 11:21 AM**

Location Address: **204 S Chester St**

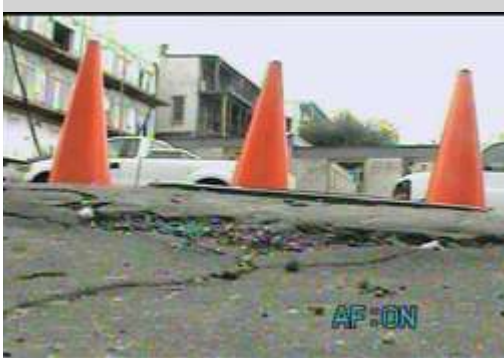
Miscellaneous

above grade

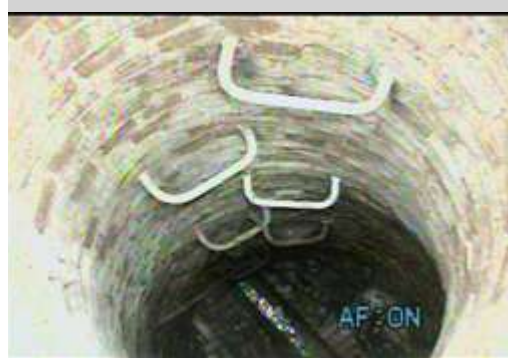
Miscellaneous

steps

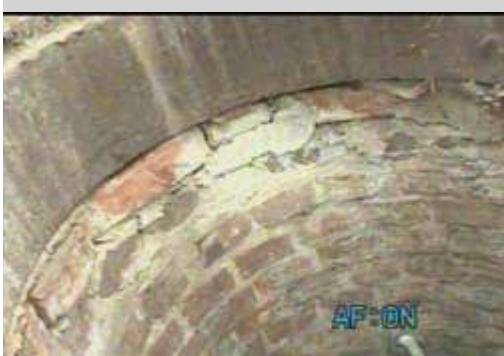
Defect 1

Condition: ☐ Sound ☒ **Cracked** ☐ Root Intrusion ☐ Loose Brick ☒ **Deteriorated**

cracked and deteriorated frame
adjustment/chimney

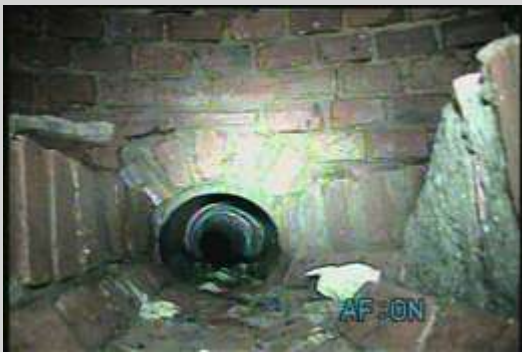
12 O'Clock Outflow

Deposits: ☐ None ☐ Mud ☐ Sludge ☒ **Debris** ☐ Grease

Silt Depth: **1** (in.) Deposits Extent: **Light**
